Asbestos Survey
Firstfields Resource Centre
42 London Road, Hailsham, East Sussex, BN27 3BU

Executive Summary

A Type 2 Survey has been carried out at Firstfields Resource Centre, 42 London Road, Hailsham, East Sussex, BN27 3BU.

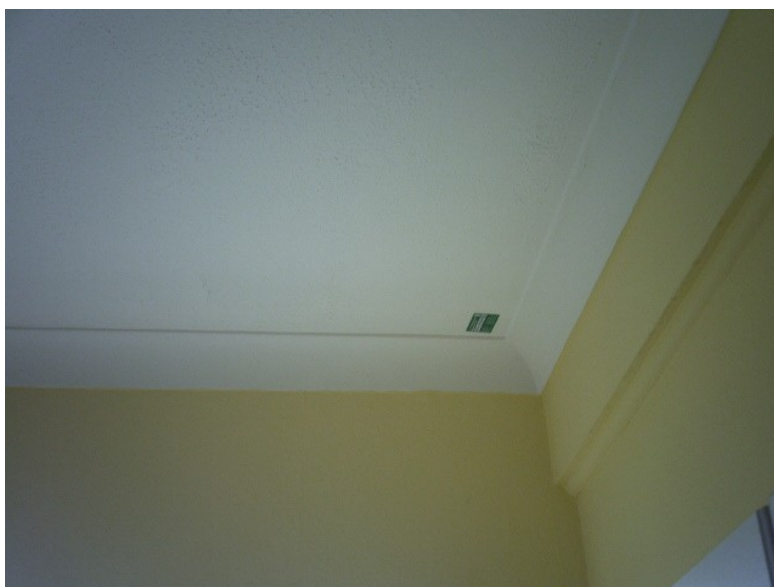
Sample No.	31636-001	Product Type	Textured Coating	1
	Photo 31636-001.jpg	Condition	Good Condition	-
Building	Firstfields Resource Centre	Surface Treatment	Sealed	-
Floor	First	Asbestos Type	Chrysotile	1
Room	001 - Kitchen	Material Risk Assessment		2
Item	Textured Coating	Item Risk Classification	Very Low Risk	
Extent & Location	8sqm - Ceiling	Highest Risk Classification for Room	Very Low Risk

Main Recommendations: Manage

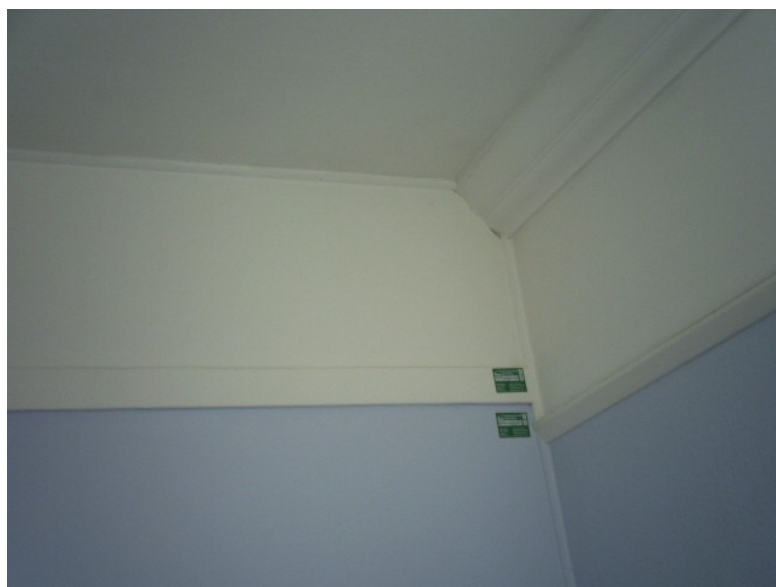
Sample No.	31636-002	Product Type	Insulating Board	2
	Photo 31636-002.jpg	Condition	Good Condition	-
Building	Firstfields Resource Centre	Surface Treatment	Sealed	1
Floor	First	Asbestos Type	Amosite, Chrysotile	2
Room	008 - Corridor	Material Risk Assessment		5
Item	Insulating Board	Item Risk Classification	Low Risk	
Extent & Location	3lin.m - High Level Beading To Wall	Highest Risk Classification for Room	Low Risk

Main Recommendations: Manage

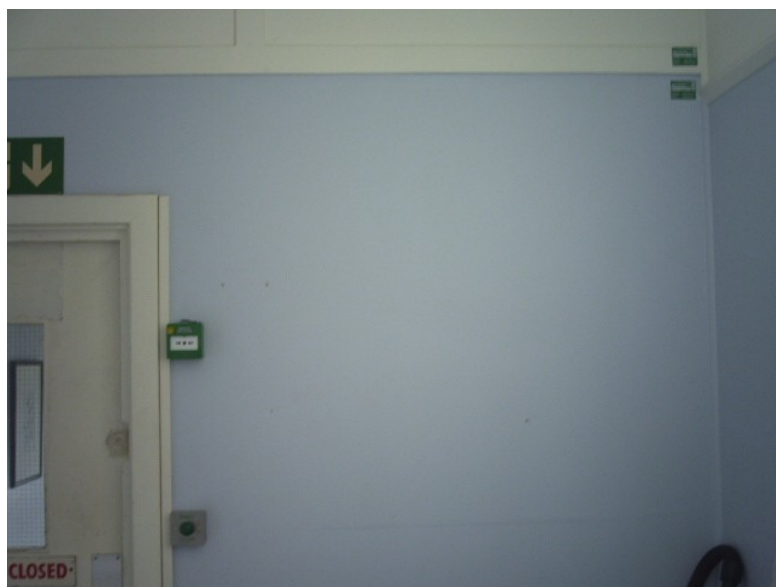
Sample No.	31636-003	Product Type	Insulating Board	2
	Photo 31636-003.jpg	Condition	Good Condition	-
Building	Firstfields Resource Centre	Surface Treatment	Sealed	1
Floor	First	Asbestos Type	Amosite, Chrysotile	2
Room	008 - Corridor	Material Risk Assessment		5
Item	Insulating Board	Item Risk Classification	Low Risk	
Extent & Location	6sqm - Wall To Stairwell 016	Highest Risk Classification for Room	Low Risk

Main Recommendations: Manage

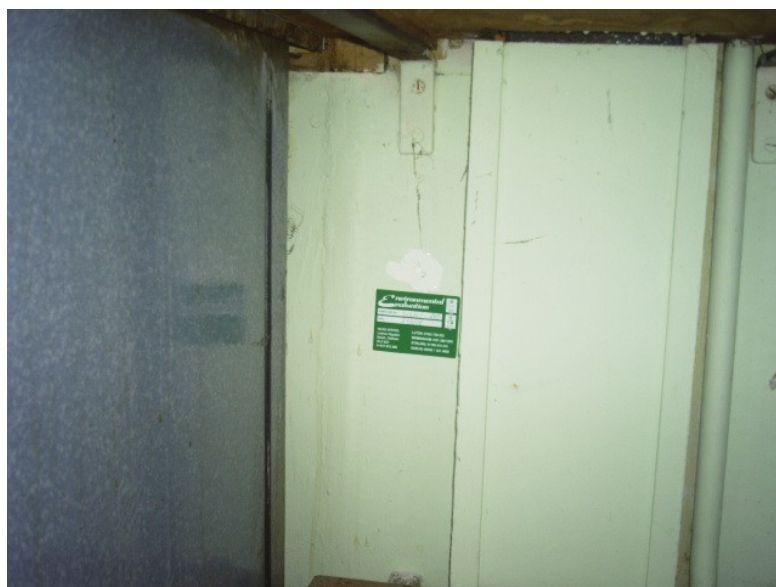
Sample No.	31636-005	Product Type	Insulating Board	2
	Photo 31636-006.jpg	Condition	Good Condition	-
Building	Firstfields Resource Centre	Surface Treatment	Sealed	1
Floor	Ground	Asbestos Type	Amosite, Chrysotile	2
Room	037 - Kitchen	Material Risk Assessment		5
Item	Insulating Board Panels	Item Risk Classification	Low Risk	
Extent & Location	1.5sqm - Wall Beneath Counter	Highest Risk Classification for Room	Low Risk

Main Recommendations: Manage

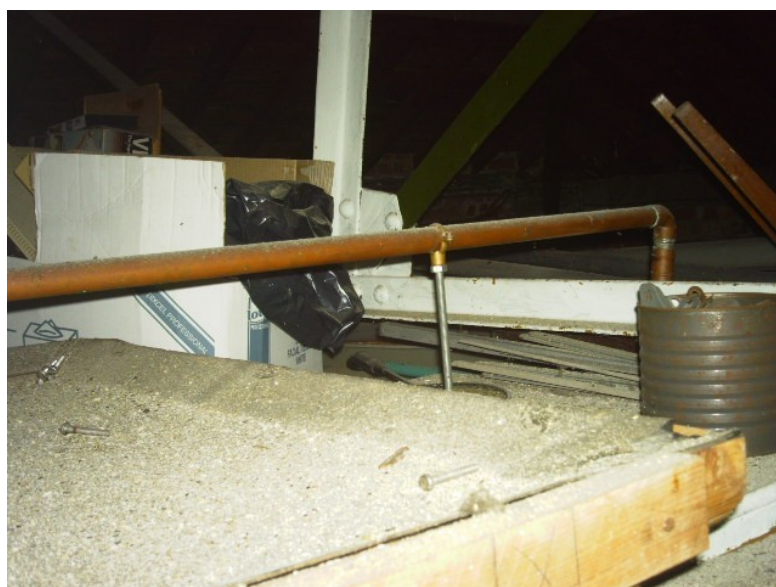
Sample No.	31636-007	Product Type	Asbestos Reinforced Composite	1
	Photo 31636-008.jpg	Condition	Good Condition	-
Building	Firstfields Resource Centre	Surface Treatment	Unsealed	1
Floor	First	Asbestos Type	Chrysotile	1
Room	044 - Roof Void	Material Risk Assessment		3
Item	Bitumen Underlay	Item Risk Classification	Very Low Risk	
Extent & Location	2sqm - Beneath Water Tank	Highest Risk Classification for Room	Very Low Risk

Main Recommendations: Manage

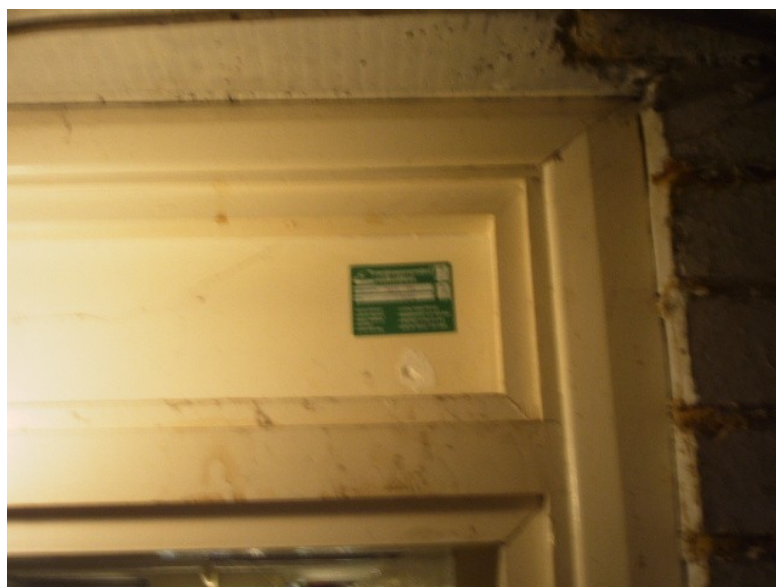
Sample No.	31636-008	Product Type	Insulating Board	2
	Photo 31636-009.jpg	Condition	Good Condition	-
Building	Firstfields Resource Centre	Surface Treatment	Sealed	1
Floor	Basement	Asbestos Type	Amosite, Chrysotile	2
Room	048 - Boiler Room	Material Risk Assessment		5
Item	Insulating Board Panel	Item Risk Classification	Low Risk	
Extent & Location	x1 - Above Door	Highest Risk Classification for Room	Medium Risk

Main Recommendations: Remove

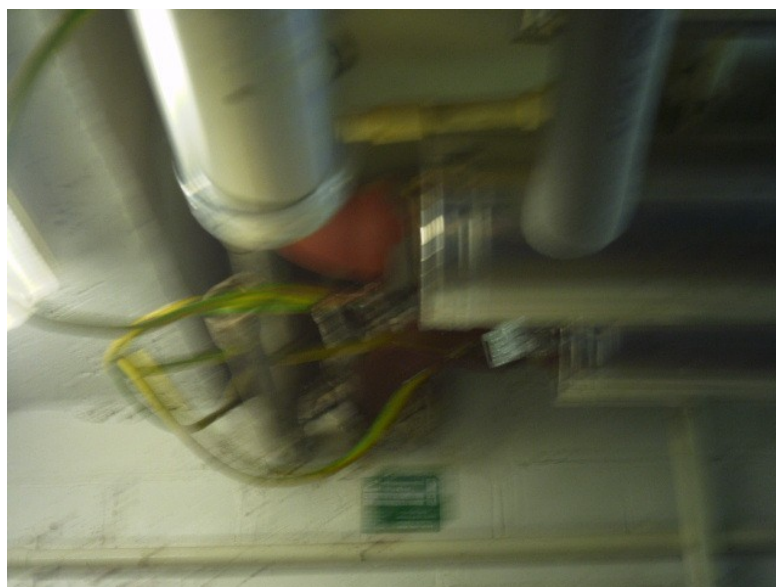
Sample No.	31636-009	Product Type	Insulation	3
	Photo 31636-010.jpg	Condition	Significant Damage	2
Building	Firstfields Resource Centre	Surface Treatment	Unsealed	3
Floor	Basement	Asbestos Type	Chrysotile	1
Room	048 - Boiler Room	Material Risk Assessment		9
Item	Pipe Insulation	Item Risk Classification	Medium Risk	
Extent & Location	x2 - High Level Adjacent Entrance Beam	Highest Risk Classification for Room	Medium Risk

Main Recommendations: Remove
