ASBESTOS RE-INSPECTION REPORT

Client	SECAMB
Site	Halisham London Road Halisham East Sussex, BN27 3BU
Date started	4 Nov 2016 to 7 Nov 2016
Date completed	7 Nov 2016
Date report issued	28 Nov 2016
Survey reference	J203478
Lead surveyor	Chriss Conner
Assistant surveyor	N/A
UPRN	N/A

Halisham London Road Halisham East Sussex
BN27 3BU

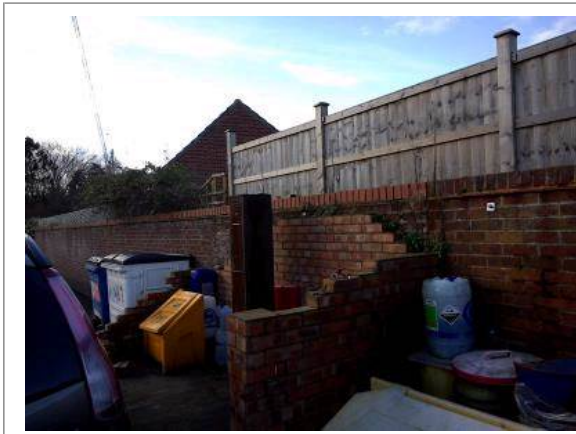
Item Reference	J203478 #1	
Sample reference number		
Client name	SECAMB	
Site address	Halisham London Road Halisham East Sussex, BN27 3BU	
Date surveyed	04/11/16 TO 07/11/16	
Date analysed		
Building	Hailsham Ambulance Station	
Floor level	External	
Room	External	
Position	Soffit to Tyre Store	
Item description	insulating board	
Condition / damage		
Surface treatment		
Product type		
Asbestos Type		
Extent		
Recommended Action	Disturbance location	
Comments:	Occupant activity	
	Time in area	
	Frequency of use	
Maintenance activity	Accessibility	
Maintenance frequency	Priority assessment score	
Number of occupants	Material assessment score	
Overall assessment score	Risk code	Removed
Material Status Change: Removed	Reinspection Comments: Removed

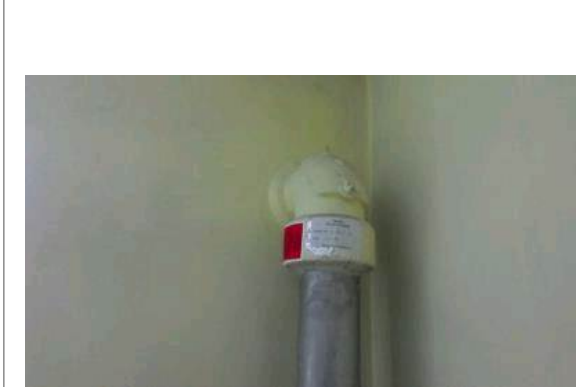
Item Reference	J203478 #2		
Sample reference number	FR6/13-R2/001 {LD004221}*		
Client name	SECAMB		
Site address	Halisham London Road Halisham East Sussex, BN27 3BU		
Date surveyed	04/11/16 TO 07/11/16		
Date analysed			
Building	Hailsham Ambulance Station		
Floor level	Ground Floor		
Room	Female WC		
Position	Flue

Item description	Cement		
Condition / damage	(0) Good Condition		
Surface treatment	(1) Enclosed sprays and lagging, Sealed AIB, asbestos cement, textured coating, gasket		
Product type	Asbestos Cement		
Asbestos Type	Chrysotile		
Extent	1no.		
Recommended Action	Monitor and manage		
Comments:	Disturbance location	Rooms up to 100m ²	
	Occupant activity	Rare disturbance - (e.g. little used store room)	
	Time in area	<1 hour - toilets	
	Frequency of use	Daily	
Maintenance activity	Minor disturbance - e.g. possibility of contact when gaining access	Accessibility	Low
Maintenance frequency	ACM unlikely to be disturbed for maintenance	Priority assessment score	3
Number of occupants	1 to 3	Material assessment score	3
Overall assessment score	6	Risk code	Risk code E
Material Status Change: No Change	Reinspection Comments: Priority assessment has been updated.

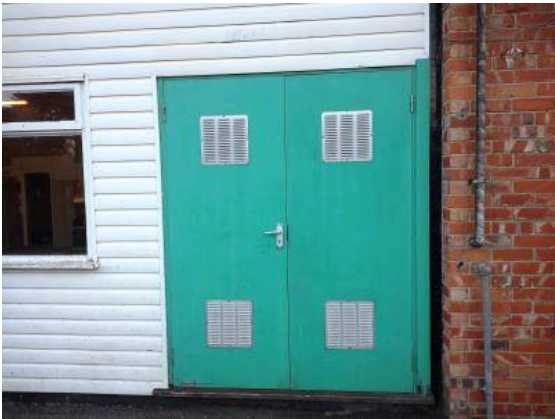
Item Reference	J203478 #3	
	Sample reference number	FR6/13-R2/004 {LD004222}*	
	Client name	SECAMB	
	Site address	Halisham London Road Halisham East Sussex, BN27 3BU	
	Date surveyed	04/11/16 TO 07/11/16	
	Date analysed		
	Building	Hailsham Ambulance Station	
	Floor level	Ground Floor	
	Room	Boiler	
	Position	Flue

Item description	Cement	
	Condition / damage	(0) Good Condition	
	Surface treatment	(1) Enclosed sprays and lagging, Sealed AIB, asbestos cement, textured coating, gasket	
Product type	Asbestos Cement		
Asbestos Type	Chrysotile		
Extent	3m		
Recommended Action	Monitor and manage	Disturbance location	Rooms up to 100m ²
Comments:	No staff on site.	Occupant activity	Rare disturbance - (e.g. little used store room)
		Time in area	<1 hour - toilets
		Frequency of use	Daily
Maintenance activity	Minor disturbance - e.g. possibility of contact when gaining access	Accessibility	Low
Maintenance frequency	ACM unlikely to be disturbed for maintenance	Priority assessment score	3
Number of occupants	None	Material assessment score	3
Overall assessment score	6	Risk code	Risk code E
Material Status Change: Unable to Access		Reinspection Comments:

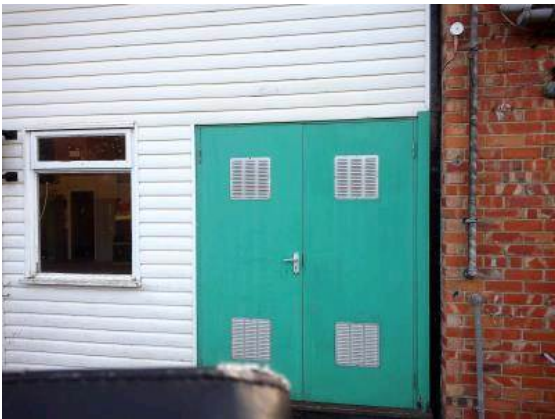
Item Reference	J203478 #4	
	Sample reference number	FR6/13-R2/005 {LD004223}*	
	Client name	SECAMB	
	Site address	Halisham London Road Halisham East Sussex, BN27 3BU	
	Date surveyed	04/11/16 TO 07/11/16	
	Date analysed		
	Building	Hailsham Ambulance Station	
	Floor level	Ground Floor	
	Room	Boiler	
	Position	Upstand over the door

Item description	insulating board	
	Condition / damage	(0) Good Condition	
	Surface treatment	(1) Enclosed sprays and lagging, Sealed AIB, asbestos cement, textured coating, gasket	
Product type	Asbestos Insulating Board		
Asbestos Type	Amosite		
Extent	2m ²		
Recommended Action	Monitor and manage	Disturbance location	Rooms up to 100m ²
Comments:	No staff on site	Occupant activity	Periodic disturbance - (e.g. industrial activity)
		Time in area	3 to 6 hours
		Frequency of use	Infrequent
Maintenance activity	Low disturbance - e.g. changing light bulbs in asbestos insulating board ceiling	Accessibility	Low
Maintenance frequency	<1 per year	Priority assessment score	6
Number of occupants	1 to 3	Material assessment score	5
Overall assessment score	11	Risk code	Risk code D
Material Status Change: Unable to Access		Reinspection Comments:

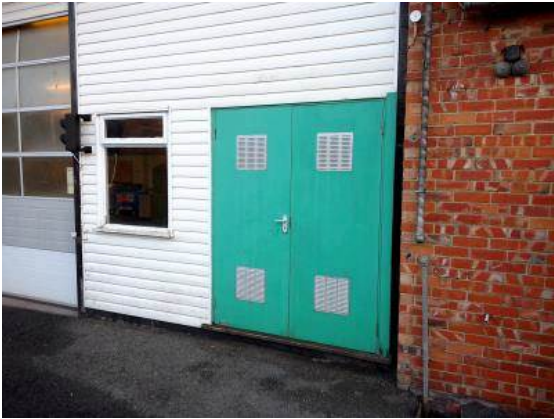
Item Reference	J203478 #6
		Sample reference number	
		Client name	SECAMB
		Site address	Halisham London Road Halisham East Sussex, BN27 3BU
		Date surveyed	04/11/16 TO 07/11/16
		Date analysed	
		Building	Hailsham Ambulance Station
		Floor level	Ground Floor
		Room	Boiler
		Position	Penetration panels

Item description	insulating board
		Condition / damage	(0) Good Condition
		Surface treatment	(1) Enclosed sprays and lagging, Sealed AIB, asbestos cement, textured coating, gasket
	Product type	Asbestos Insulating Board	
	Asbestos Type	Strongly Presumed Amosite	
	Extent	2no.	
Recommended Action	Monitor and manage	Disturbance location	Rooms up to 100m ²
Comments:	No staff on site	Occupant activity	Low disturbance - (e.g. office type activity)
		Time in area	<1 hour - toilets
		Frequency of use	Infrequent
Maintenance activity	Minor disturbance - e.g. possibility of contact when gaining access	Accessibility	Low
Maintenance frequency	ACM unlikely to be disturbed for maintenance	Priority assessment score	2
Number of occupants	None	Material assessment score	5
Overall assessment score	7	Risk code	Risk code D
Material Status Change: Unable to Access		Reinspection Comments:

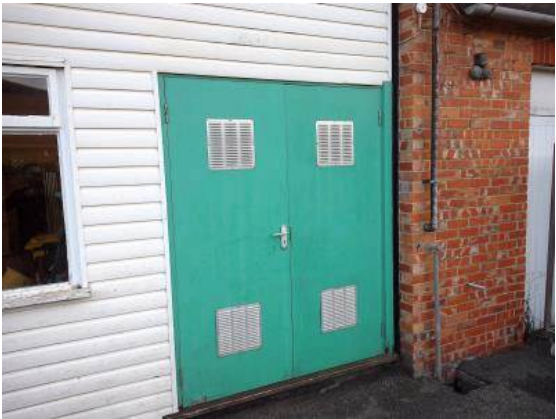
Item Reference	J203478 #7
		Sample reference number	
		Client name	SECAMB
		Site address	Halisham London Road Halisham East Sussex, BN27 3BU
		Date surveyed	04/11/16 TO 07/11/16
		Date analysed	
		Building	Hailsham Ambulance Station
		Floor level	Ground Floor
		Room	Boiler
		Position	Ceiling

Item description	insulating board
		Condition / damage	(0) Good Condition
		Surface treatment	(1) Enclosed sprays and lagging, Sealed AIB, asbestos cement, textured coating, gasket
Product type	Asbestos Insulating Board		
Asbestos Type	Strongly Presumed Amosite		
Extent	2m ²		
Recommended Action	Monitor and manage	Disturbance location	Rooms up to 100m ²
Comments:		Occupant activity	Periodic disturbance - (e.g. industrial activity)
		Time in area	3 to 6 hours
		Frequency of use	Infrequent
Maintenance activity	Low disturbance - e.g. changing light bulbs in asbestos insulating board ceiling	Accessibility	Low
Maintenance frequency	>1 per year	Priority assessment score	7
Number of occupants	None	Material assessment score	5
Overall assessment score	12	Risk code	Risk code D
Material Status Change: Unable to Access		Reinspection Comments:

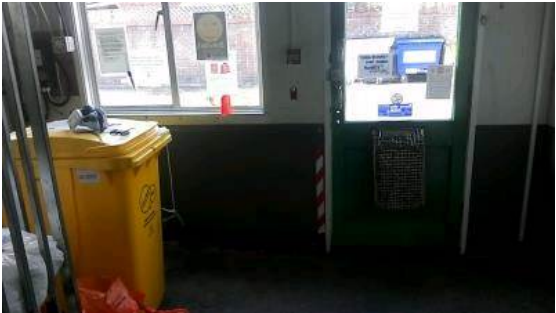
Material	Priority	Total		
J203478 #8	FR6/13-R2/006 {LD004224}*	Hailsham Ambulance Station	Ground Floor	Garage	Walls	insulating board	Amosite	6	6	12	Risk code C	
Comments								Low Material Risk				
Risk cod C where damaged or paint peeled.						11/2017	20m²	Encapsulate				
Material Status Change: No Change						Reinspection Comments: Area of damage identified above roller door. Material assessment has been updated. Priority assessment has been updated.

Item Reference	J203478 #8
		Sample reference number	FR6/13-R2/006 (LD004224)*
		Client name	SECAMB
		Site address	Halisham London Road Halisham East Sussex, BN27 3BU
		Date surveyed	04/11/16 TO 07/11/16
		Date analysed	
		Building	Hailsham Ambulance Station
		Floor level	Ground Floor
		Room	Garage
		Position	Walls

Item description	insulating board
		Condition / damage	(1) Low Damage
		Surface treatment	(1) Enclosed sprays and lagging, Sealed AIB, asbestos cement, textured coating, gasket
Product type	Asbestos Insulating Board		
Asbestos Type	Amosite		
Extent	20m ²		
Recommended Action	Encapsulate	Disturbance location	Rooms over 100m ² or well-venti
Comments: Risk cod C where damaged or paint peeled.		Occupant activity	Periodic disturbance - (e.g. industrial activity)
		Time in area	<1 hour - toilets
		Frequency of use	Daily
Maintenance activity	Minor disturbance - e.g. possibility of contact when gaining access	Accessibility	Low
Maintenance frequency	ACM unlikely to be disturbed for maintenance	Priority assessment score	6
Number of occupants	4 to 10	Material assessment score	6
Overall assessment score	12	Risk code	Risk code C
Material Status Change: No Change		Reinspection Comments: Area of damage identified above roller door. Material assessment has been updated. Priority assessment has been updated.

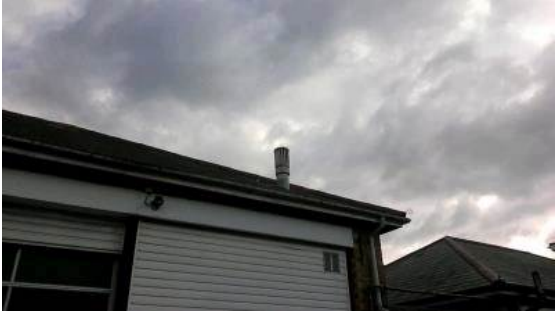
Item Reference	J203478 #9	
	Sample reference number		
	Client name	SECAMB	
	Site address	Halisham London Road Halisham East Sussex, BN27 3BU	
	Date surveyed	04/11/16 TO 07/11/16	
	Date analysed		
	Building	Hailsham Ambulance Station	
	Floor level	External	
	Room	External	
	Position	Roof cowl (from boiler flue)

Item description	Cement	
	Condition / damage	(0) Good Condition	
	Surface treatment	(1) Enclosed sprays and lagging, Sealed AIB, asbestos cement, textured coating, gasket	
	Product type	Asbestos Cement	
	Asbestos Type	Strongly Presumed Chrysotile	
Extent	1no.		
Recommended Action	Monitor and manage	Disturbance location	External
Comments:		Occupant activity	Rare disturbance - (e.g. little used store room)
		Time in area	<1 hour - toilets
		Frequency of use	Infrequent
Maintenance activity	Minor disturbance - e.g. possibility of contact when gaining access	Accessibility	Low
Maintenance frequency	ACM unlikely to be disturbed for maintenance	Priority assessment score	1
Number of occupants	None	Material assessment score	3
Overall assessment score	4	Risk code	Risk code E
Material Status Change: No Change		Reinspection Comments: Priority assessment has been updated.

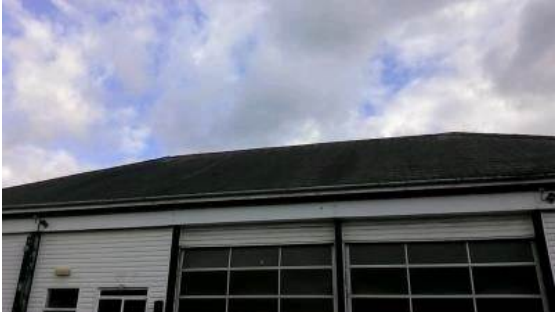
Item Reference	J203478 #10	
	Sample reference number		
	Client name	SECAMB	
	Site address	Halisham London Road Halisham East Sussex, BN27 3BU	
	Date surveyed	04/11/16 TO 07/11/16	
	Date analysed		
	Building	Hailsham Ambulance Station	
	Floor level	External	
	Room	External	
	Position	Roofs

Item description	Cement slates	
	Condition / damage	(0) Good Condition	
	Surface treatment	(1) Enclosed sprays and lagging, Sealed AIB, asbestos cement, textured coating, gasket	
	Product type	Asbestos Cement	
	Asbestos Type	Strongly Presumed Chrysotile	
Extent	250m ²		
Recommended Action	Monitor and manage	Disturbance location	External
Comments:		Occupant activity	Rare disturbance - (e.g. little used store room)
		Time in area	<1 hour - toilets
		Frequency of use	Infrequent
Maintenance activity	Minor disturbance - e.g. possibility of contact when gaining access	Accessibility	Low
Maintenance frequency	ACM unlikely to be disturbed for maintenance	Priority assessment score	1
Number of occupants	None	Material assessment score	3
Overall assessment score	4	Risk code	Risk code E
Material Status Change: No Change		Reinspection Comments: Description has been updated.

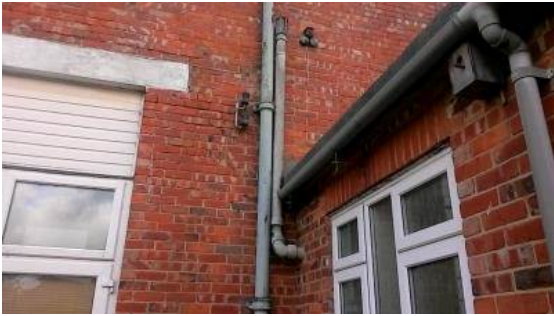
Item Reference	J203478 #11
		Sample reference number	As Sample FR6/13-R2/001 {LD004221}*
		Client name	SECAMB
		Site address	Halisham London Road Halisham East Sussex, BN27 3BU
		Date surveyed	04/11/16 TO 07/11/16
		Date analysed	
		Building	Hailsham Ambulance Station
		Floor level	External
		Room	External
		Position	Flue

Item description	Cement
		Condition / damage	(1) Low Damage
		Surface treatment	(1) Enclosed sprays and lagging, Sealed AIB, asbestos cement, textured coating, gasket
		Product type	Asbestos Cement
		Asbestos Type	Chrysotile*
	Extent	3lm	
Recommended Action	Monitor and manage	Disturbance location	External
Comments:		Occupant activity	Rare disturbance - (e.g. little used store room)
		Time in area	<1 hour - toilets
		Frequency of use	Infrequent
Maintenance activity	Minor disturbance - e.g. possibility of contact when gaining access	Accessibility	Low
Maintenance frequency	ACM unlikely to be disturbed for maintenance	Priority assessment score	1
Number of occupants	None	Material assessment score	4
Overall assessment score	5	Risk code	Risk code E
Material Status Change: No Change		Reinspection Comments:	Material assessment has been updated.

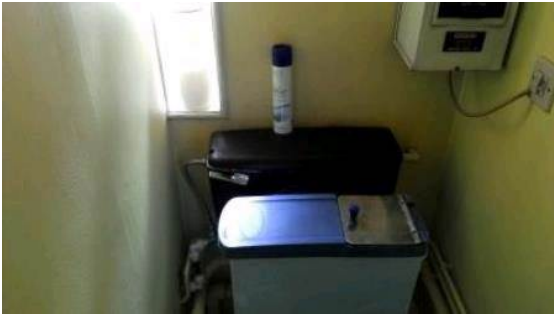
Item Reference	J203478 #12
		Sample reference number	LD004232*
		Client name	SECAMB
		Site address	Halisham London Road Halisham East Sussex, BN27 3BU
		Date surveyed	04/11/16 TO 07/11/16
		Date analysed	June 20 2014
		Building	Hailsham Ambulance Station
		Floor level	Ground Floor
		Room	Female WC
		Position	Cistern
		Item description	Reinforced resin composite
		Condition / damage	
		Surface treatment	
		Product type	
		Asbestos Type	No Asbestos Detected
	Extent		
Recommended Action		Disturbance location	
Comments:		Occupant activity	
		Time in area	
		Frequency of use	
Maintenance activity		Accessibility	
Maintenance frequency		Priority assessment score	
Number of occupants		Material assessment score	
Overall assessment score		Risk code	
Material Status Change: No Change		Reinspection Comments:

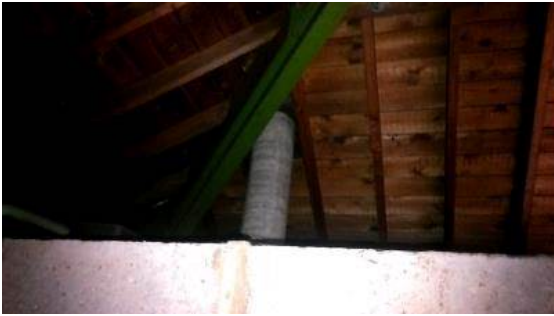
Item Reference	J203478 #13	
	Sample reference number	As Sample FR6/13-R2/004 {LD004222}*	
	Client name	SECAMB	
	Site address	Halisham London Road Halisham East Sussex, BN27 3BU	
	Date surveyed	04/11/16 TO 07/11/16	
	Date analysed		
	Building	Halisham Ambulance Station	
	Floor level	Ground Floor	
	Room	Garage	
	Position	Flue

Item description	Cement	
	Condition / damage	(0) Good Condition	
	Surface treatment	(1) Enclosed sprays and lagging, Sealed AIB, asbestos cement, textured coating, gasket	
	Product type	Asbestos Cement	
	Asbestos Type	Chrysotile*	
Extent	1no.		
Recommended Action	Monitor and manage	Disturbance location	Rooms over 100m ² or well-venti
Comments:		Occupant activity	Rare disturbance - (e.g. little used store room)
		Time in area	<1 hour - toilets
		Frequency of use	Daily
Maintenance activity	Minor disturbance - e.g. possibility of contact when gaining access	Accessibility	Low
Maintenance frequency	ACM unlikely to be disturbed for maintenance	Priority assessment score	3
Number of occupants	4 to 10	Material assessment score	3
Overall assessment score	6	Risk code	Risk code E
Material Status Change: No Change		Reinspection Comments:	Priority assessment has been updated.
