RE-INSPECTION REPORT OF KNOWN ASBESTOS

THE SALVATION ARMY

Brookfield Chapel, 28 Brookfield Road, Portsmouth, PO1 5HZ

124584-274756

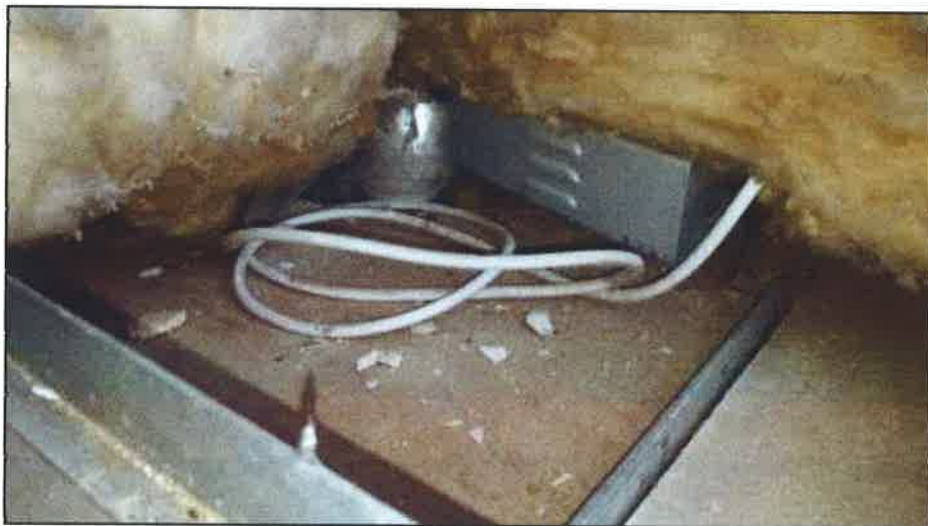
Sample No: 004

Client:	The Salvation Army	Area No:	001 & 002
Site Address:	Brookfield Chapel, 28 Brookfield Road, Portsmouth, PO1 5HZ	Floor:	Ground
Building:	001	Area Description:	Ceiling Void above Main Hall & Office
Building Address:	28 Brookfield Road	Material Description:	Debris within ceiling void
		Survey Report Reference:	124584-274756-0001

Asbestos Type: 0 - No asbestos detected

Approx Size of Item: . Small Amounts

Comments: Located sporadically throughout void

SOCOTEC Asbestos SAMPLE No	CLIENT SAMPLE No	SAMPLE LOCATION & DESCRIPTION*	FIBRE TYPE DETECTED	ANALYSIS No
004		Ground Floor - Ceiling Void above Main Hall & Office 001& 002 - Debris within ceiling void	NADIS	124584-274756-0001-004

Timescale for Recommendation : No action

Recommendation: No further action required

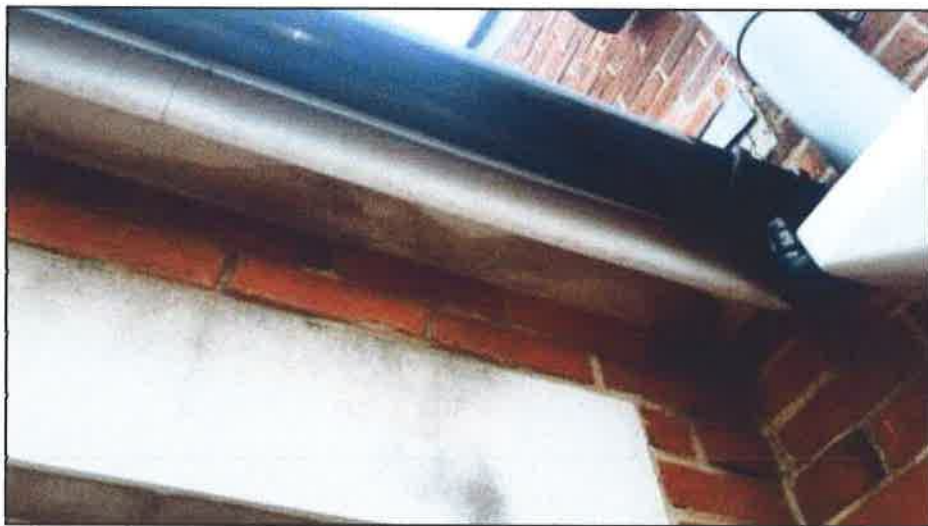
Sample No:	001
Position:	External
Approx Size of Item:	6 Linear M

Client:	The Salvation Army	Area No:	EXT
Site Address:	Brookfield Chapel, 28 Brookfield Road, Portsmouth, PO1 5HZ	Floor:	Ground
Building:	001	Area Description:	External
Building Address:	28 Brookfield Road	Material Description:	Soffit board to outside of Kitchen & Toilet
		Survey Report Reference:	124584-274756-0001

Material Risk:	3
Asbestos Type:	1 - Chrysotile
Product Type:	1 - Asbestos composites, decorative finishes, AC
Extent of Damage:	0 - Good
Surface Treatment:	1 - Enclosed sprays and lagging, AIB, AC sheets etc
Priority Risk:	1
Normal Occupant Activity:	0 - Rare Disturbance
Likelihood of Disturbance:	0 - Very Low Likelihood of Disturbance
Human Exposure Potential:	0 - Very Low Human Exposure Potential
Maintenance Activity :	1 - Low Risk Maintenance Activity

Comments:	PVC soffits also present
------------------	--------------------------

Total Risk Score:	4
--------------------------	----------

Timescale for Recommendation : 12 months

Recommendation:	Manage
------------------------	--------
