ASBESTOS SURVEY REPORT

4 NORTHGATE CHICHESTER WEST SUSSEX PO19 1BA

12 February 2016

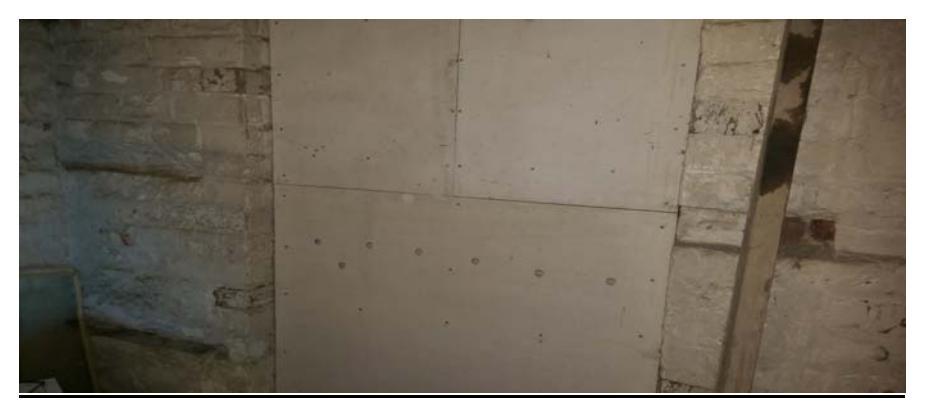
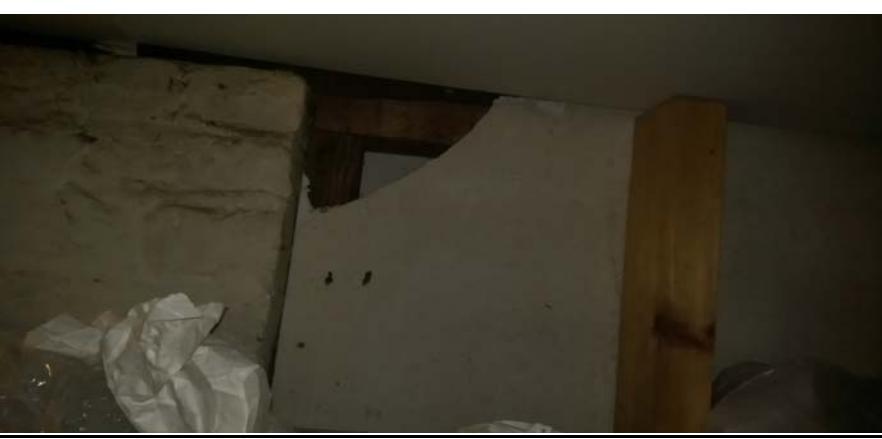
SAMPLE 1 BASEMENT COMMUNICATIONS ROOM

BOARDED UP DOORWAY [BOTH SIDES]

Sample 1			
Sample reference	NORTH 1		
Internal/external	INTERNAL		
Level	BASEMENT		
Product description	ASBESTOS MILL BOARD		
Amount	4 SQ MT		
Accessibility	USUALLY ACCESABLE, LIKELY TO BE DISTURBED		
Asbestos Type	AMOSITE / CHRYSOTILE

Sample Reference	NORTH 1
Product type	2
Extent of damage/deterioration	1
Surface treatment	2
Asbestos type	2
TOTAL	7
MEDIUM POTENTIAL TO RELEASE FIBRES

Sample	Location	Material	Quantity
Reference			
NORTH 1	BASEMENT COMMS	ASBESTOS MILL	4 SQ MT
	ROOM DOOR BLANK	BOARD	
Date analysed	Asbestos Type	Material	Action
		assessment	
12.2.16	AMOSITE /	7	PAINT / MANAGE
	CHRYSOTILE

Sample reference	Recommended action	Comments
NORTH 1	APPLY ASBESTOS BEWARE LABELS	MANAGEMENT PLAN MUST ADVISE INCOMING
	MAINTAIN ASBESTOS REGISTER	TRADESMEN OF LOCATION OF THE ASBESTOS
	ENCAPLULATE WITH SUITABLE PAINT

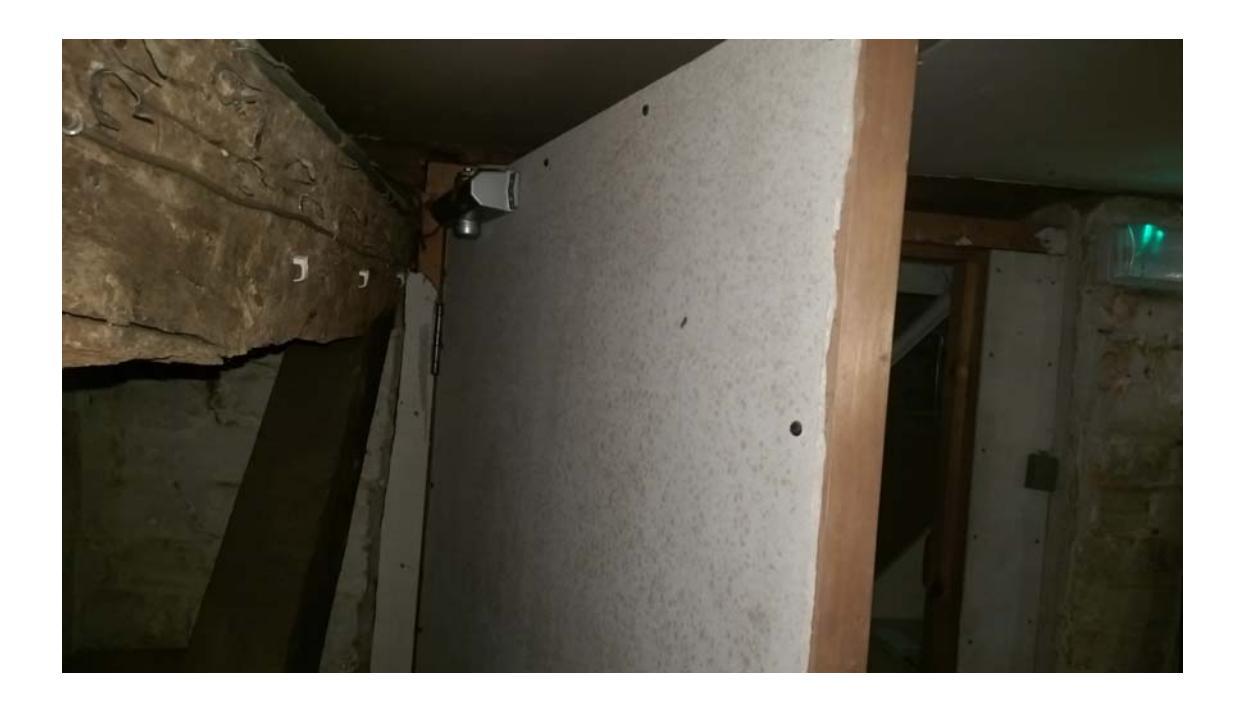
SAMPLE 2

BASEMENT STRONGROOM DOOR

Sample 2		
Sample reference	NORTH 2	
Internal/external	INTERNAL	
Level	BASEMENT	
Product description	ASBESTOS MILL BOARD	
Amount	2 SQ MTS	
Accessibility	USUALLY ACCESABLE, LIKELY TO BE DISTURBED	
Asbestos Type	AMOSITE / CHRYSOTILE

Sample Reference	NORTH 2
Product type	2
Extent of damage/deterioration	1
Surface treatment	2
Asbestos type	2
TOTAL	7
MEDIUM POTENTIAL TO RELEASE FIBRES

Sample Reference	Location	Material	Quantity
NORTH 2	BASEMENT STRONG ROOM DOOR	ASBESTOS MILL BOARD	2 SQ MT
Date analysed	Asbestos Type	Material assessment	Action
12.2.16	AMOSITE / CHRYSOTILE	7	PAINT / MANAGE

Sample reference	Recommended action	Comments
NORTH 2	APPLY ASBESTOS BEWARE LABELS	MANAGEMENT PLAN MUST ADVISE INCOMING
	MAINTAIN ASBESTOS REGISTER	TRADESMEN OF LOCATION OF THE ASBESTOS
	ENCAPLULATE WITH SUITABLE PAINT

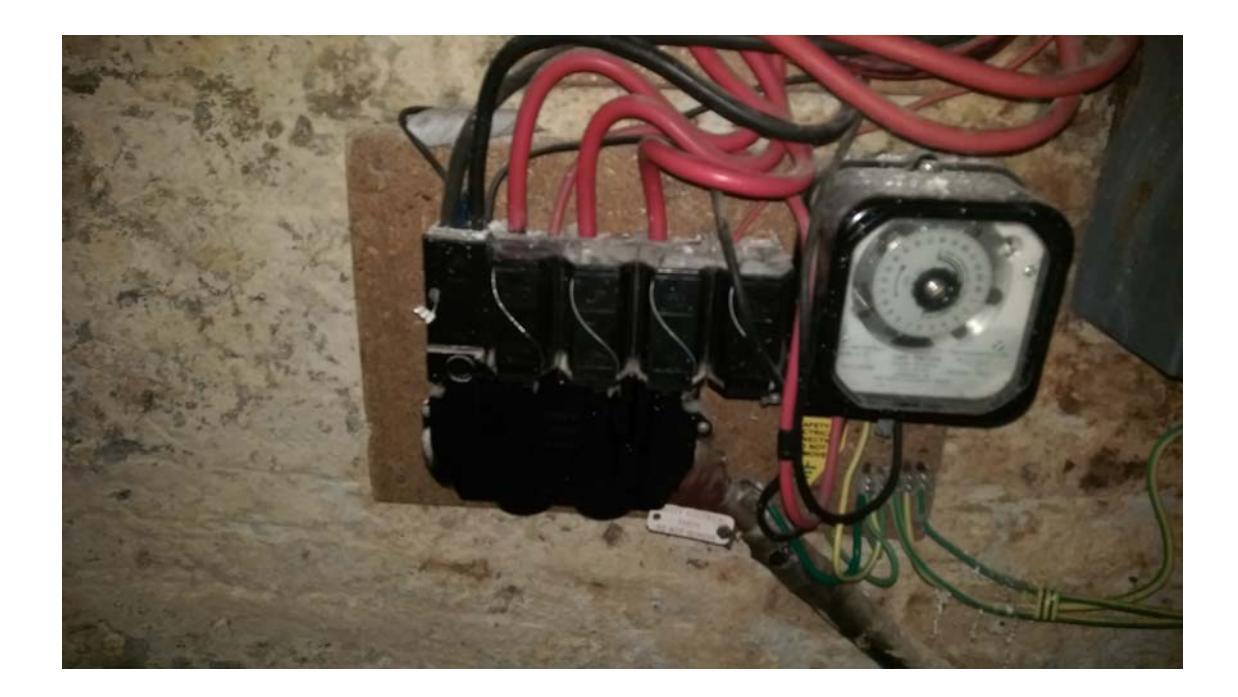
NOTIONAL SAMPLE 3 – STRONGLY PRESUMED

MAIN FUSE FLASH BACK X 4

Sample 3			
Sample reference	NO SAMPLE TAKEN		
Internal/external	INTERNAL		
Level	BASEMENT		
Product description	PRESUMED RAW FIBRE		
Amount	MINIMAL		
Accessibility	USUALLY ACCESABLE, LIKELY TO BE DISTURBED		
Asbestos Type	STRONGLY PRESUMED AMOSITE / CHRYSOTILE

Sample Reference	Location	Material	Quantity
NORTH 3	MAIN FUSE BOARD	STRONGLY PRESUMED AMOSITE / CHRYSOTILE	MINIMAL
Date analysed	Asbestos Type	Material	Action
N/A	AMOSITE / CHRYSOTILE	N/A	MANAGE

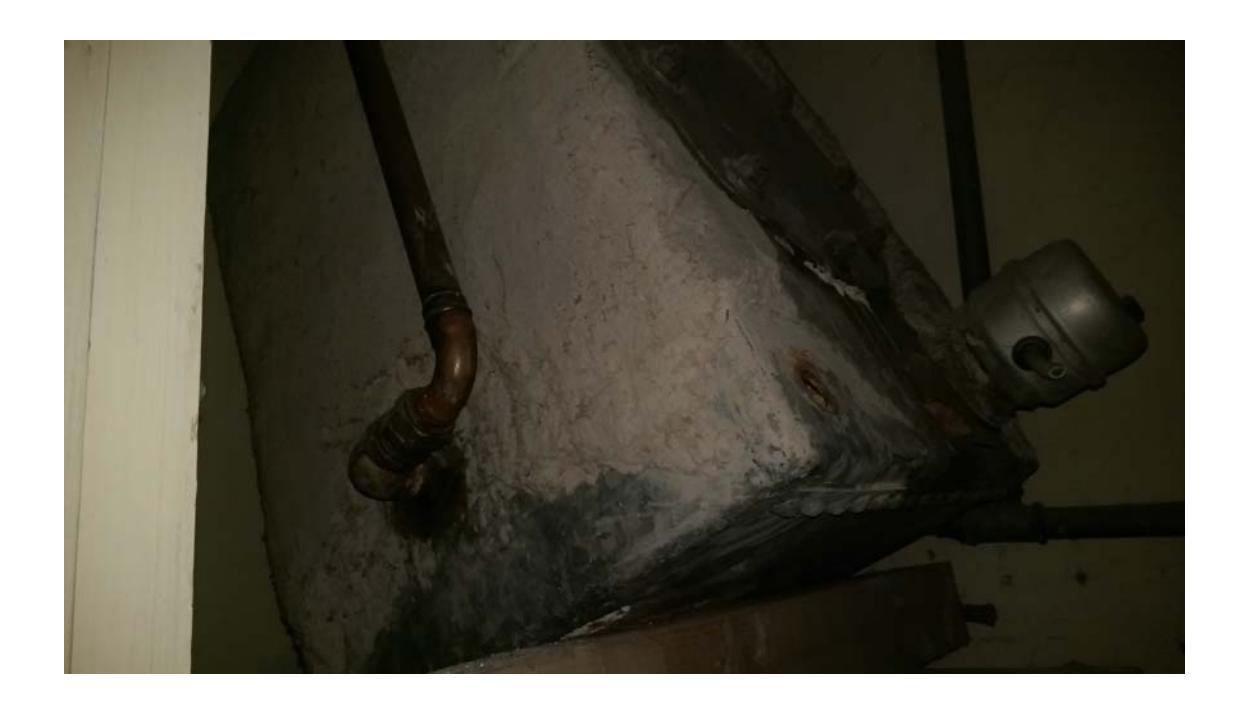
SAMPLE 4

HOT WATER TANK INSULATION

Sample 2			
Sample reference	NORTH 2		
Internal/external	INTERNAL		
Level	1 ST FLOOR STAIR HEAD		
Product description	FIBRE		
Amount	2 SQ MTS		
Accessibility	USUALLY ACCESABLE, LIKELY TO BE DISTURBED		
Asbestos Type	NO ASBESTOS DETECTED
